## MARINE SURVEY

“ [REDACTED] ”

**Grand Banks 42 Classic**

Date: **November 14, 2005**

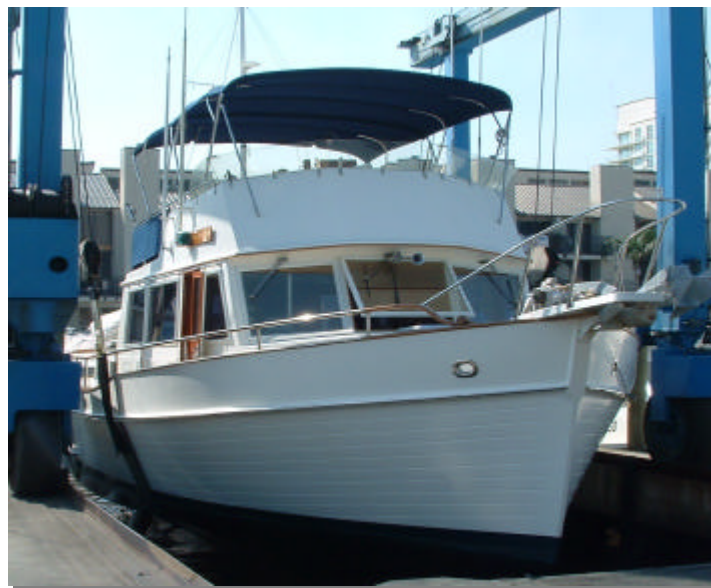
### **HULL IDENTIFICATION NUMBER**

The vessel's Hull Identification Number (HIN) was photographed at the time of this survey inspection. The above number represents the image of the HIN as taken from the subject vessel, by the undersigned surveyor. The HIN and other numbers in this report were recorded where accessible and listed in this report for identification of the vessel and her related equipment. The vessel's Official Number (Document) was recorded from the vessel's hull markings. The expiration date on the hull decal was checked and a discrepancy was noted in the currency of the registration (see recommendations).

- 1) The vessel's Florida registration stickers, on the hull and on the tender, were expired and should be renewed.
- 2) The air conditioning raw water intake hose (below the waterline) had a number of sections that were cracked. The cracked hoses should be replaced. Some of the hose barbs for the hose connections were PVC fittings. PVC is not approved for use below the waterline and should be replaced with hardware rated for below waterline applications.

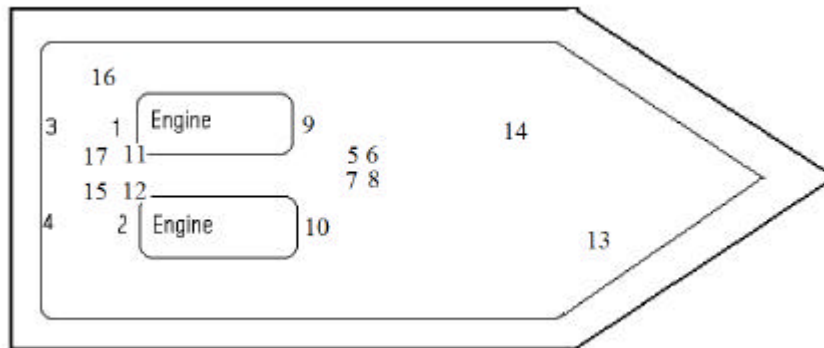
**THRUHULL FITTINGS**

- 1) Stuffing Box 5) Head Intake 9) Engine Intake 13) Waste Discharge 17) Knotmeter/Transducer

- 2) Stuffing Box    6) A/C Intake                      10) Engine Intake      14) Head Intake
- 3) Rudder Post    7) Refrigerator Intake                      11) Generator Intake    15) Head Intake
- 4) Rudder Post    8) Water Maker Intake                      12) Waste Discharge    16) Waste Discharge

The diagram above depicts the approximate location of the accessible thruhull penetrations below the waterline and is not intended to be to scale. The thruhull fittings below the waterline were fitted with seacocks or secured. All accessible seacocks were found in functioning condition. All accessible hoses connected to seacocks below the waterline were secured with double hose clamps. The thruhull fittings below the waterline were protected from galvanic deterioration by a bonding system. The condition of the bonding system was found in generally in good overall condition.
